SERVICE BULLETIN #1

May 3, 1979
Page 1 of 4

Subject: Horizontal tail to fuselage front attach tubes.

Models Affected: All M-4 and M-5 Series Aircraft.

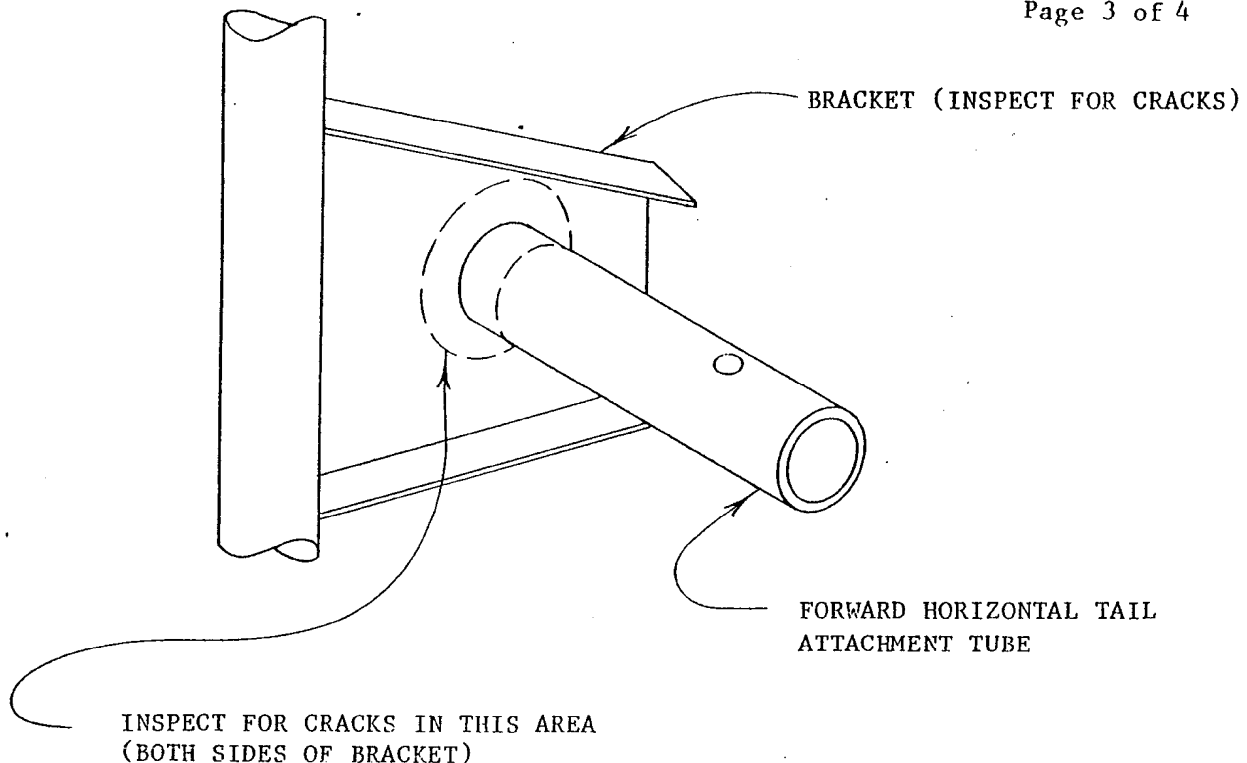
DETAIL A

Background: There is possibility that the fuselage tube attaching
the front attach point of the horizontal tail may be cracked.

1. Inspect for cracks on the horizontal fuselage tube
and bracket that attaches to the front attachment
of the horizontal tail at the bracket weld joint.
(See attached sketches), both left and right side
of the fuselage.

(INSPECT LEFT AND RIGHT SIDES OF THE FUSELAGE)

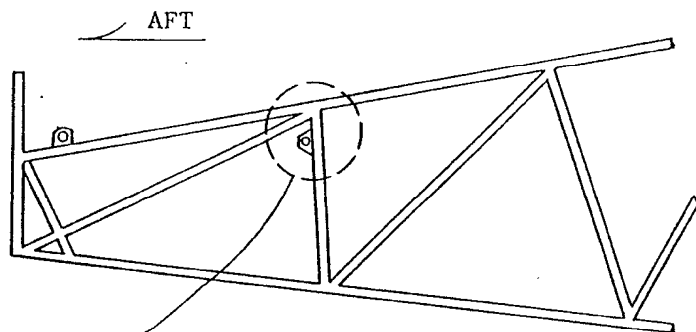
SIDE VIEW
M-4 SERIES

INSPECT THIS AREA
FOR CRACKS (SEE
DETAIL A)

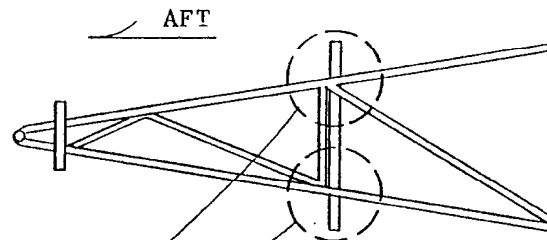
TOP VIEW
M-5 SERIES

INSPECT THIS AREA FOR
CRACKS (SEE DETAIL A)
