Maule Aircraft Corporation

SERVICE BULLETIN #2

Subject: Rudder Bar Assembly.

Models Affected: All M-4 and M-5 Series Aircraft.

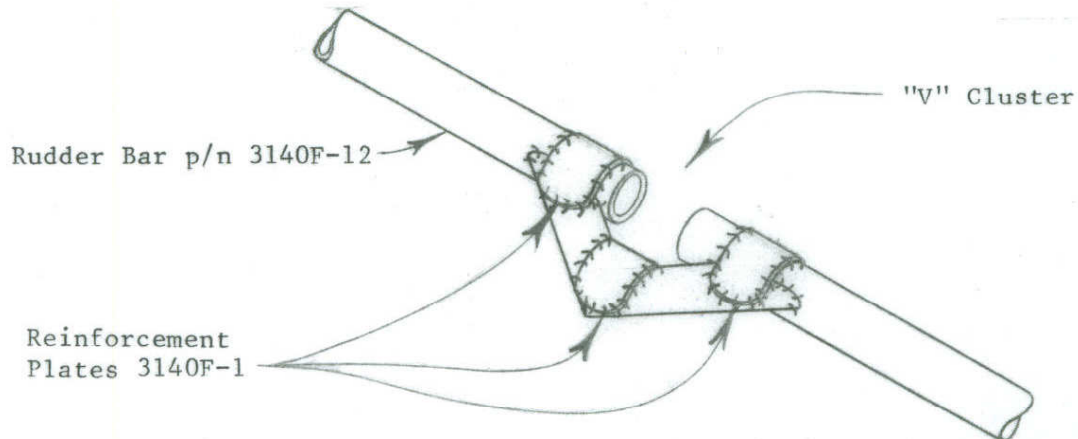
Background: There is a possibility that the horizontal tubes of the
rudder bar may be cracked or may become cracked where "V" cluster
attaches.

- c. Locate and weld reinforcement plates p/n 3140F-1 as shown in sketch:

- d. After welding, clean affected area and repaint.
