# Service Bulletin No. 22

Page 1 of 3  
Date: 1/26/04

**SUBJECT:** Wiring to Avionics Converter installed under right front seat

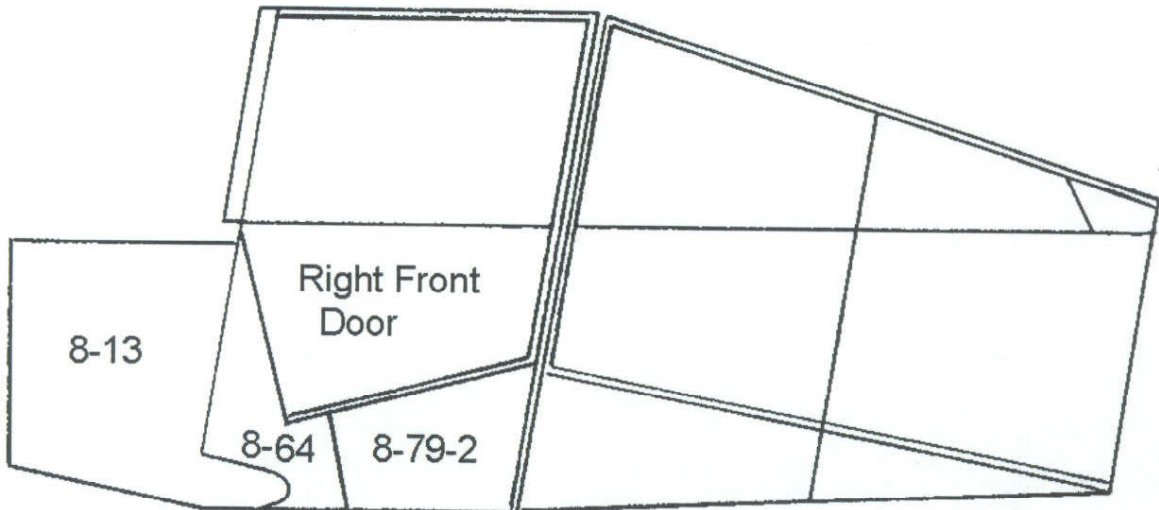
Sketch #1

Interior Panel Locations -  
Right Side View From Inside

3. Loosen forward kick panel (8-13) and remove panel (8-64) under forward door opening. Refer to accompanying sketch for locations. Remove panel (8-79-2) if necessary for inspection.

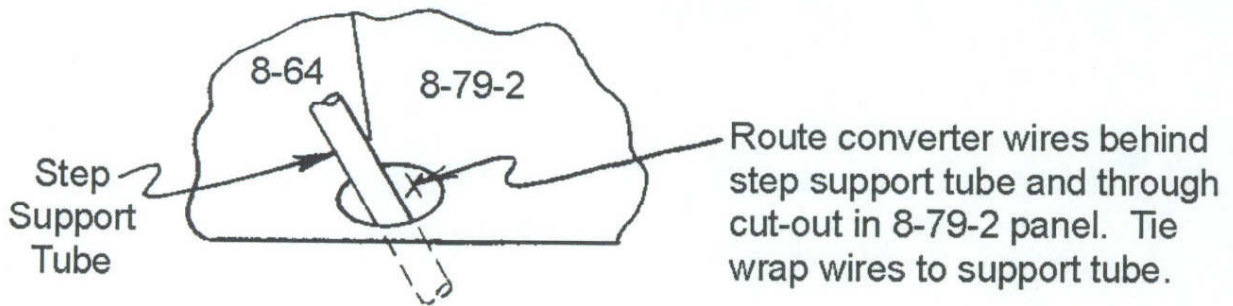
Sketch #2

4. Inspect converter wiring where it passes through panels at step support tube. Look for evidence of cutting, abrasion, or arcing where wires pass through the panels adjacent to the step support tube.

5. Replace any damaged wiring and reroute the wiring if necessary to agree with Sketch #2, page 2. Enlarge the opening in the panel if necessary. Clean and repaint any area on the step support tube that suffered from arcing. Replace or repair the (8-64) and (8-79-2) panels if burned.
