Service Bulletin No. 30

SUBJECT: Elevator cable connections

AIRPLANES AFFECTED: All models manufactured up to 12/07/07.

MAULE AEROSPACE TECHNOLOGY, INC.
Service Bulletin No. 30

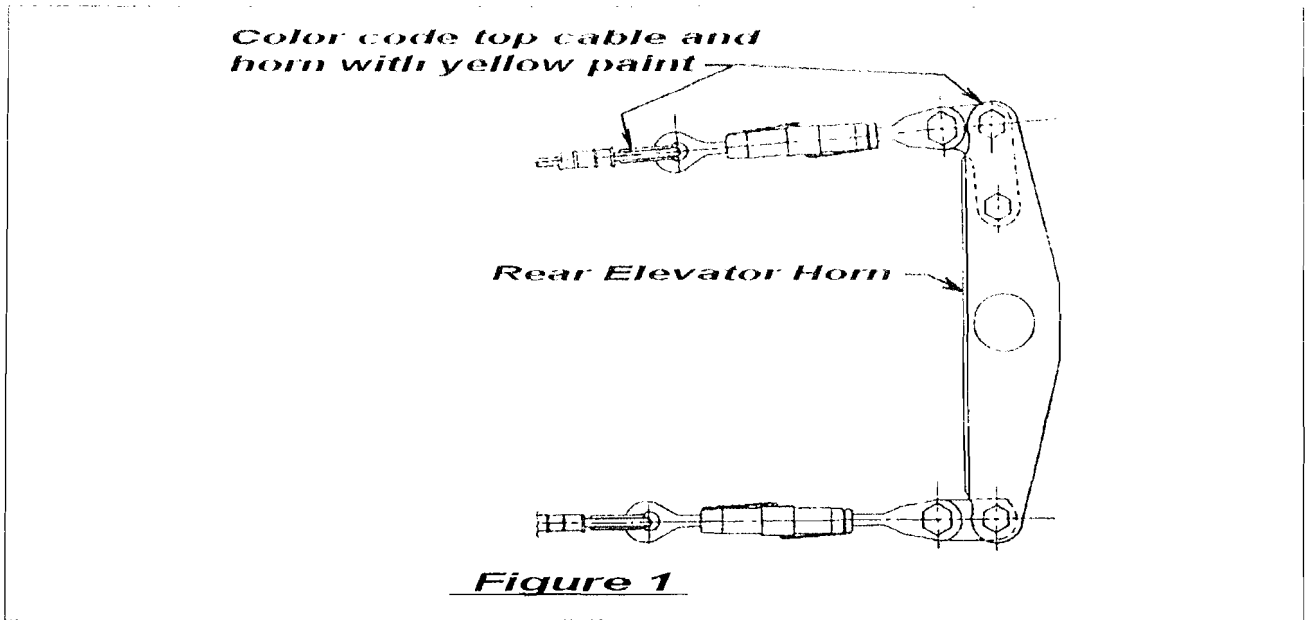
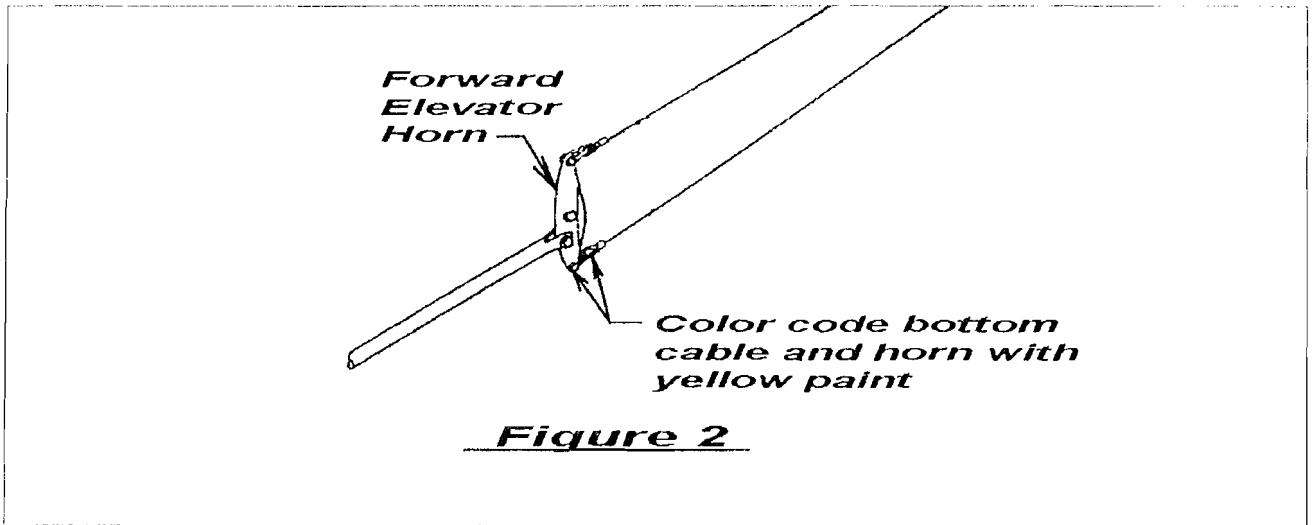
BACKGROUND: There is the possibility when the elevator cables are disconnected or replaced, that they could be reconnected backwards, reversing the control yoke actions and resulting in down elevator when the yoke is pulled aft. There have been two reports of this occurrence to date resulting in minor injuries to a pilot and passenger and major damage to an aircraft from nose over.

1. Remove rear inspection hole cover at tail located over horizontal stabilizer, left or right side.
2. Using yellow enamel paint, color code the top elevator control cable and the top of the elevator control horn at location shown in Figure 1 of this service bulletin. Reinstall inspection hole cover.
3. Remove bolt from under left or right front seat and flip seat back. Remove cable cover, if necessary, and apply yellow enamel paint to color code bottom elevator control cable and bottom forward elevator control horn. Ref. Figure 2. Reverse procedure to reassemble installation.
4. After paint dries, check for any binding of the control cables by moving the control wheel full travel fore and aft. Check for proper movement of the elevator, elevator moves up when pulling back on the control wheel.
5. Insert the Maintenance Manual Supplement located on page 3 into your Maintenance Manual.
