SERVICE BULLETIN No. 9

SUBJECT: Elevator Control Cable Attachments.

AIRCRAFT AFFECTED: All Maule Models.

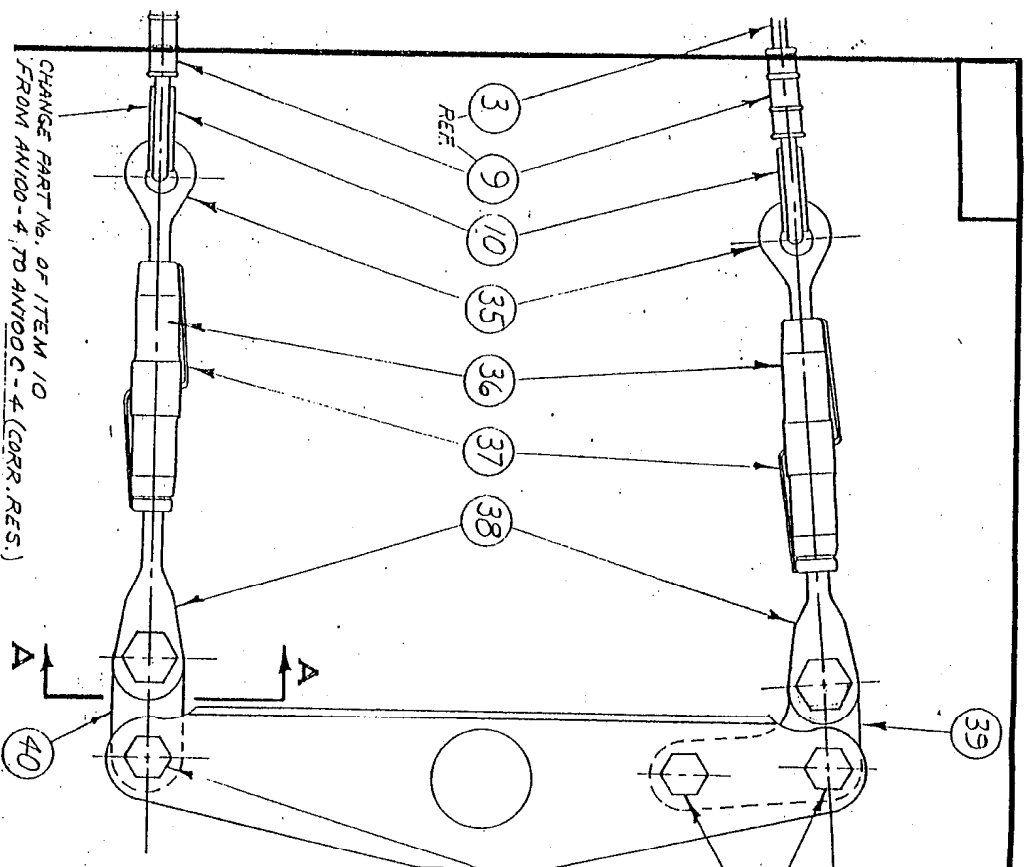
MAULE
 MOULTRIE
 AEROSPACE TECHNOLOGY, INC.
 GEORGIA
 SERVICE BULLETIN No. 9, Pg. 2 of 3

REF. ELEVATOR CONTROL SYSTEM DRAWING NO. 3097E

CHANGE PART No. OF ITEM 10 FROM AN100-4 TO AN100C-4 (CORR. RES.)

TORQUE TO SPEC. S-18

NOTES:
 1) INSTALL BOLTS, NUTS, AND WASHERS AS SHOWN.
 2) NO SUBSTITUTION FOR CORROSION RESISTANT PARTS.
 3) COAT ALL CABLE ATTACHMENT PARTS AND LINKS WITH PARAL-KETONE, LPS 3, OR EQUIVALENT.

TIGHTEN FINGERTIGHT THEN BACK OFF ONE OR TWO COTTER PIN SLOTS AND INSTALL COTTER PIN. JOINT MUST ROTATE FREELY.

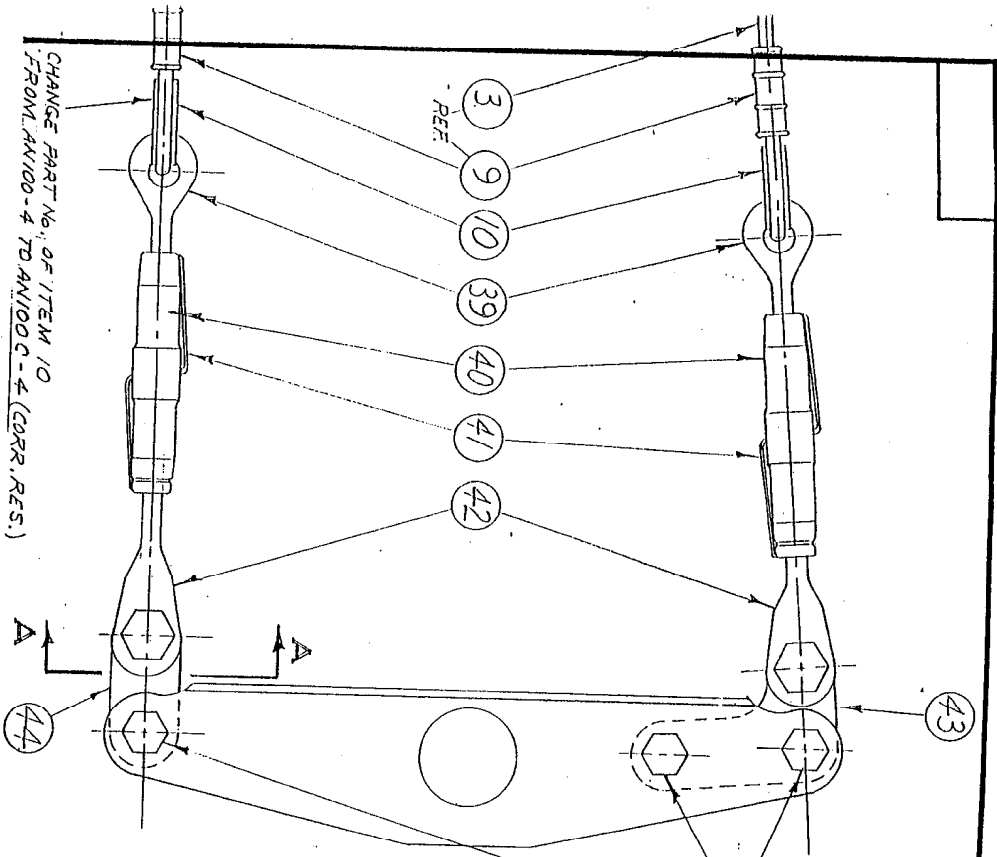
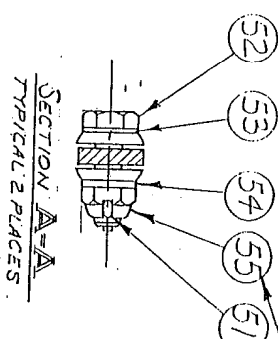
MAULE AEROSPACE TECHNOLOGY INC.
MOULTRIE GEORGIA
SERVICE BULLETIN No. 9, Pg. 3 of 3

REF. ELEVATOR CONTROL SYSTEM DRAWING No. 3174F

TORQUE TO SPEC. 5-18
48 49 47 50 51

NOTES:
1) INSTALL BOLTS, NUTS, AND WASHERS AS SHOWN.
2) NO SUBSTITUTION FOR CORROSION RESISTANT PARTS.
3) COAT ALL CABLE ATTACHMENT PARTS AND LINKS WITH PARAL-KETONE, LPS 3, OR EQUIVALENT.

TIGHTEN FINGERTIGHT, THEN BACK OFF ONE OR TWO COTTER PIN SLOTS AND INSTALL COTTER PIN. JOINT MUST ROTATE FREELY.
