Maule Aircraft Corporation

SERVICE LETTER #38

SUBJECT: Possible float plane reinforcement deficiency.

MODELS AFFECTED: M-5-235C, S/N 7073C thru 7077C, 7079C, and 7085C.

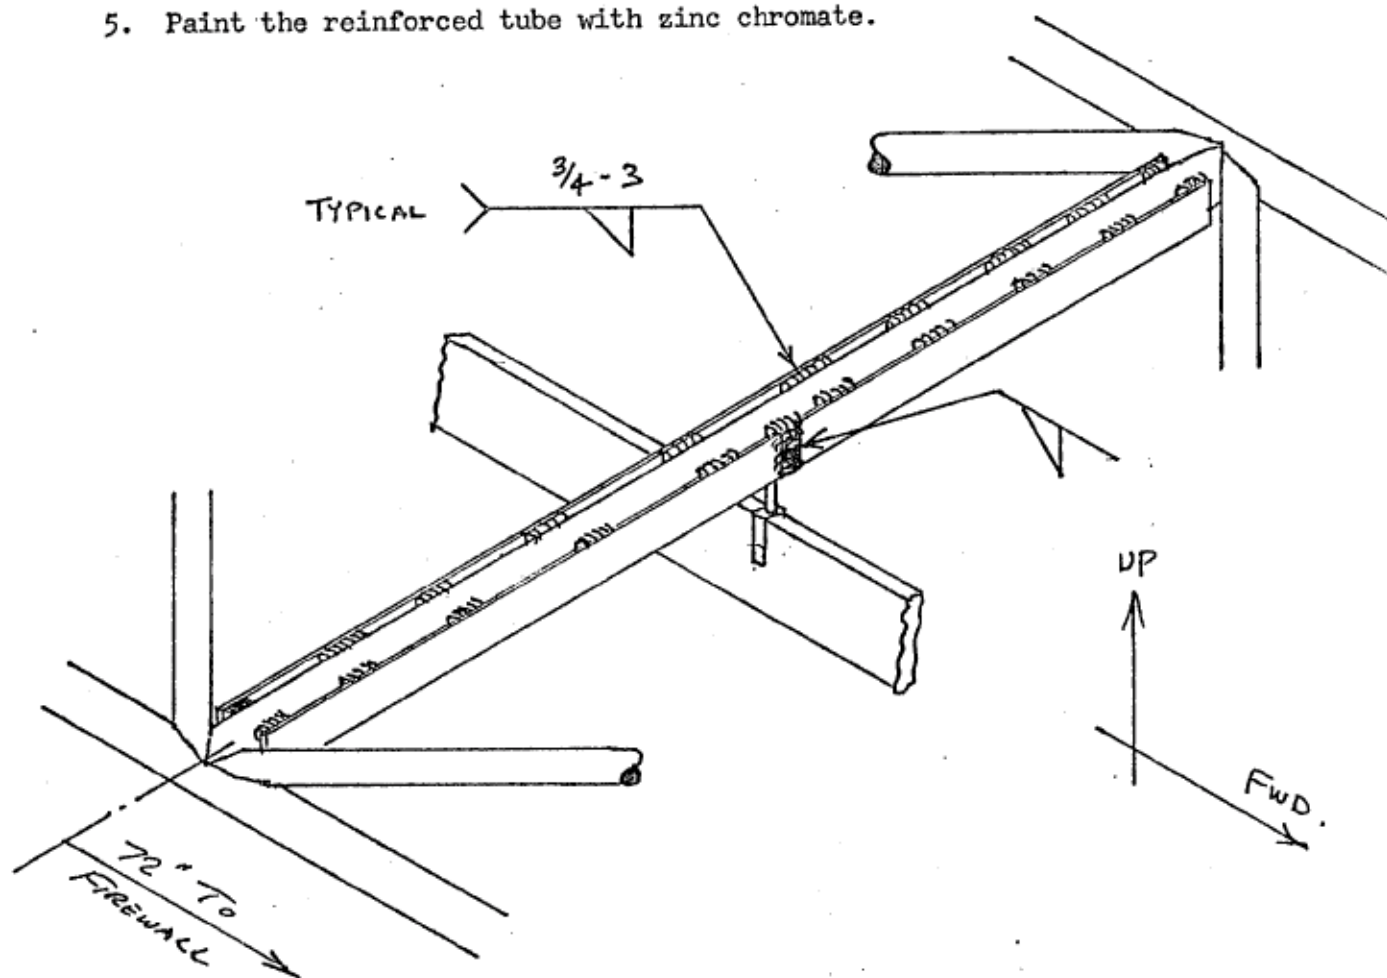
REINFORCEMENT INSTALLATION INSTRUCTIONS

BACKGROUND: There is a possibility that tube #127 (Fuselage bottom, transverse, at the rear/cargo door junction) was not reinforced when the float plane reinforcement kit was installed on these airplanes.

1. Slide reinforcing tube into fuselage belly below and behind tube to be reinforced, with the channel opening up and the slot forward.
2. Align the slot in the reinforcement with the fabric Stand-off tube and slide the reinforcement up around tube #127, still with the channel opening up.
3. Clamp the reinforcement to the tube and weld both sides of the channel, at the top, to the tube, using a $3/4$ inch fillet weld every three inches.

CAUTION: Spread wet cloths over the fabric in the area being welded, and have a fire extinguisher handy.

4. Weld slot closed.
5. Paint the reinforced tube with zinc chromate.
