Maule Aircraft Corporation

Service Letters #24, #25, #26, and #27

To: All owner's of Maule Models M-4-180C and M-4-220C/S aircraft, Serial Numbers 3001C - 3006C, 2001S, 2001C - 2126C, 2129C - 2175C and 2177C.

SERVICE LETTER NO. 26

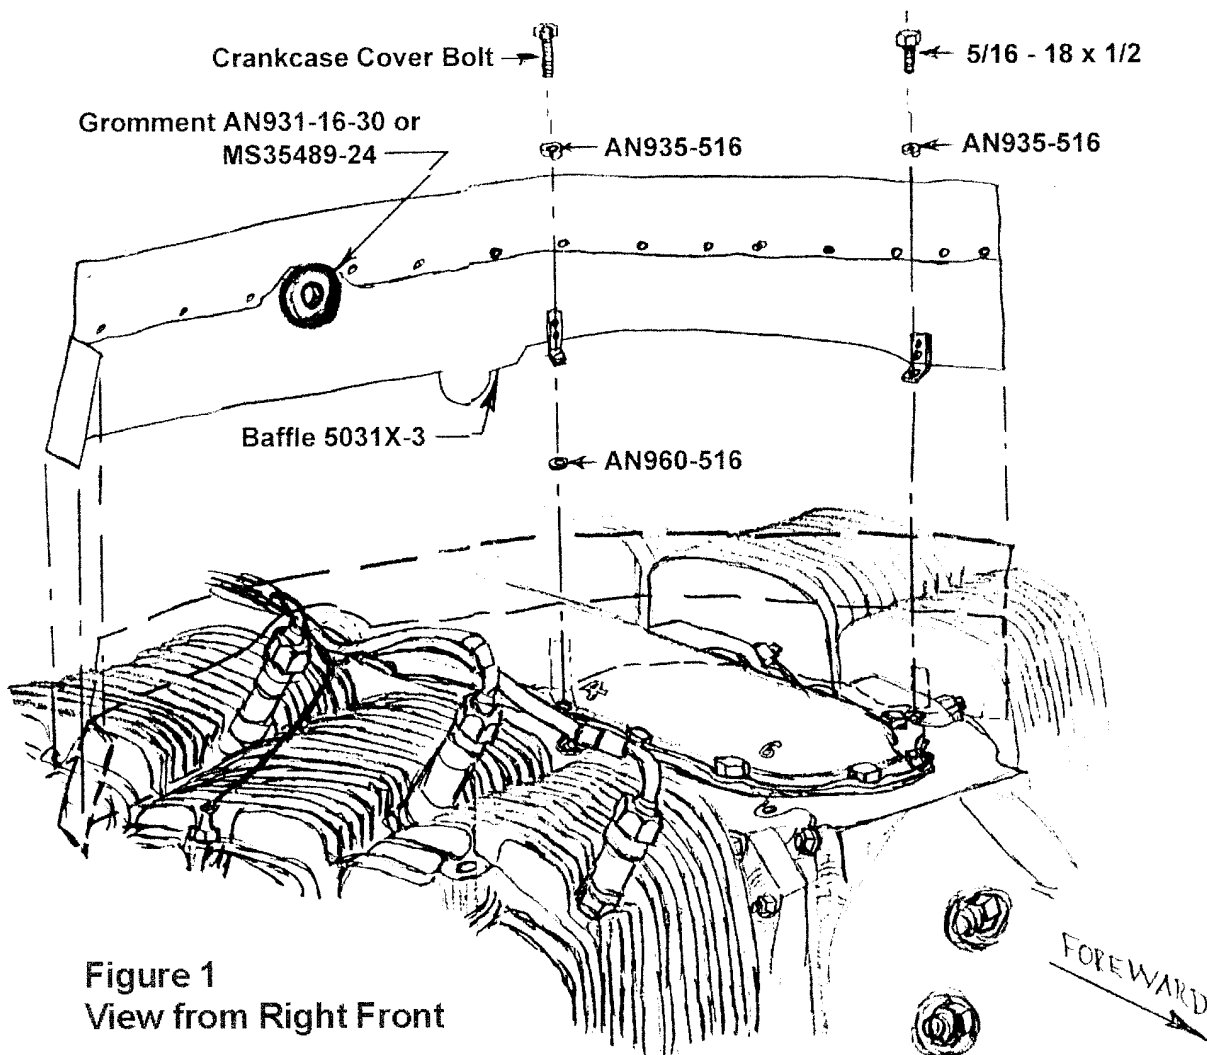
Background: In an effort to allow continuous full throttle engine operation, it has been found necessary to improve the engine cooling.

3. Install the rubber Grommet in the hole in the Baffle.
4. Remove the Top Crankcase Bolt as shown on Figure 1.
5. Install the Baffle in the position shown in Figure 1.

6. Mount the Baffle by placing a washer, p/n AN960-516, under and a Lock Washer, p/n AN935-516, on top of the Brace using the Top Crankcase Bolt removed in step 4 for securement torquing to 60 to 75 inch pounds.

7. Use a Lock Washer p/n AN935-516, over the other Brace and secure with a 5/16 - 18 x 1/2" long Bolt to the Cylinder Base Temperature Probe Hole as shown in Figure 1.

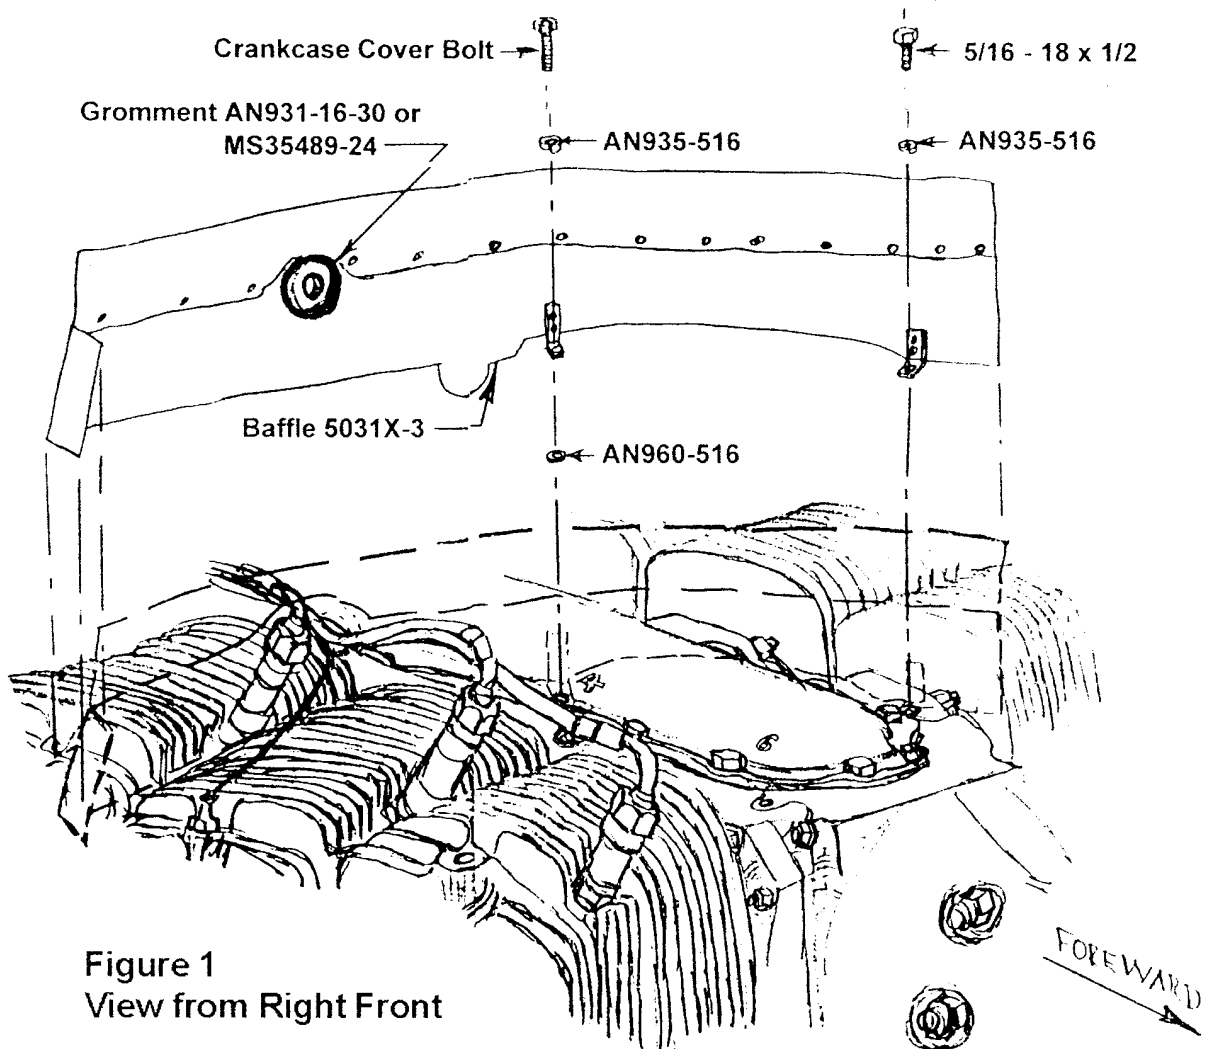
Figure 1
View from Right Front

Background: In an effort to allow continuous full throttle engine operation, it has been found necessary to improve the engine cooling.

3. Install the rubber Grommet in the hole in the Baffle.
4. Remove the Top Crankcase Bolt as shown on Figure 1.
5. Install the Baffle in the position shown in Figure 1.

6. Mount the Baffle by placing a washer, p/n AN960-516, under and a Lock Washer, p/n AN935-516, on top of the Brace using the Top Crankcase Bolt removed in step 4 for securement torquing to 60 to 75 inch pounds.

7. Use a Lock Washer p/n AN935-516, over the other Brace and secure with a 5/16 - 18 x 1/2" long Bolt to the Cylinder Base Temperature Probe Hole as shown in Figure 1.
