## **Service Bulletin No. 33**

**SUBJECT:** Inspection and the repair if required, of tubing located at the aft lower edge of right side cargo door opening in floatplanes.

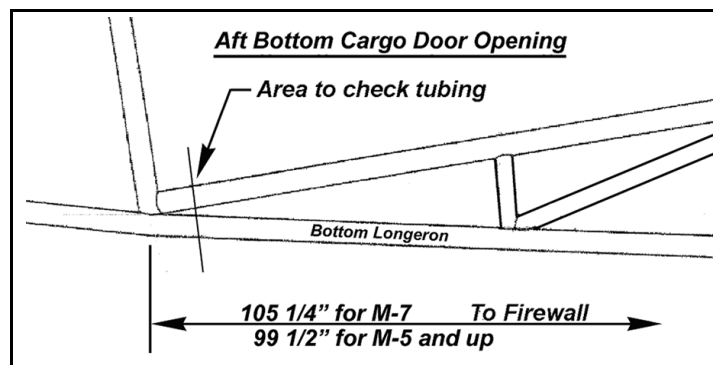
**BACKGROUND:** Recently in a floatplane, a break was discovered in the frame tubing located at the aft lower edge of right side cargo door opening and also a break in the tubing located forward of the weld cluster in the lower longeron directly below the other cut.

1. Remove floorboard fasteners attaching the aft right side floorboard. Lift corner of floorboard and slide upholstery panel from under cargo door opening sill trim. Inspect frame tubing in two places for cracks to the longeron and the tubing above in an area between weld cluster and approximately 4 inches forward. (See sketch below)
2. If tubing is satisfactory, no further action is required.
3. If either or both of the tubing are unsatisfactory (broke), refer to FAR 43.13 for repair instructions.
