## Service Bulletin No. 35

**SUBJECT:** Upper aileron cable interference with rub block and wing skin where the cable exits the wing skin.

**AIRPLANES AFFECTED:** All Maule airplanes.

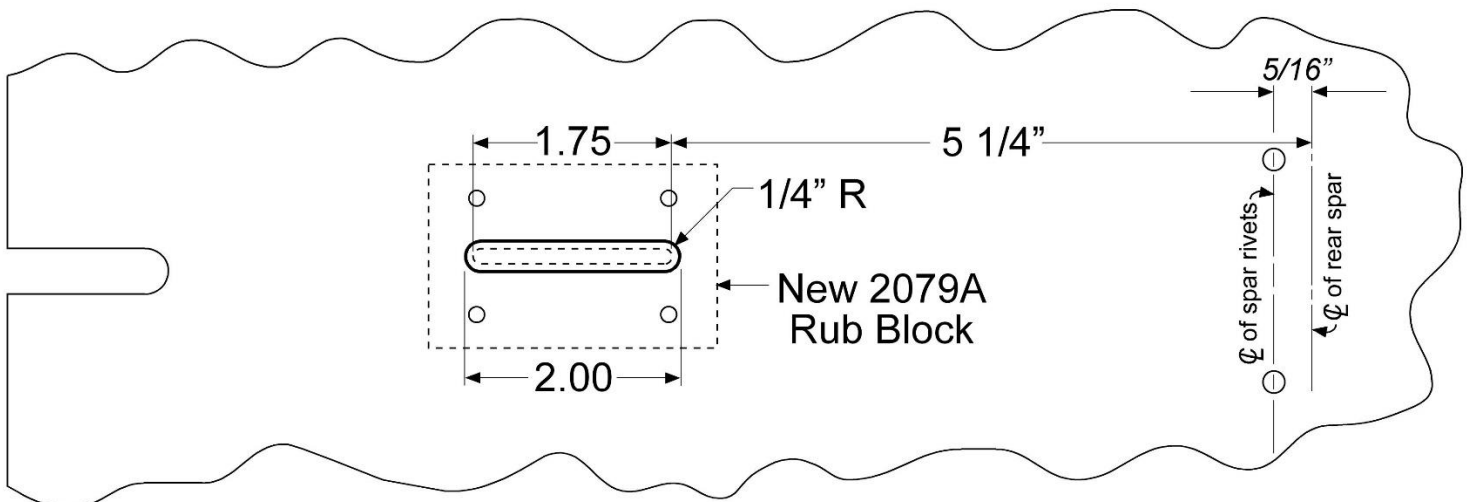
**BACKGROUND:** Recently during an FAA product audit on a completed aircraft, it was discovered that the aileron cable where it exits the top wing skin had no clearance on the rub block and wing skin at full deflection. Inspection of other aircraft that were available for inspection revealed minimal clearance on these other aircraft. Maule has received no field reports of this issue but feel that in the interest of safety it should be addressed on all Maule aircraft.

**ACTION TO BE TAKEN:** Before further flight inspect aileron cables at full deflection where they exit the top wing skin for any interference and/or cable wear. If sufficient clearance exists and there is no sign of cable wear or fraying, no further action is necessary. If interference is found but there is no cable wear or fraying this will require the rub block replacement portion of this action only. If interference is found and there are signs of wear or fraying of the aileron cable, this will require aileron cable and rub block replacement. There is a new aileron cable rub block available (P/N 2079A) with a  $\frac{1}{2}$ " longer opening. This will require routing or filing the wing skin slot  $\frac{1}{2}$ " ( $\frac{1}{4}$ " at both ends) in accordance with the illustration #1 shown below.
